O&M INSPECTION REPORT FOR NAVIGATION PROJECTS

MANELE SMALL BOAT HARBOR

Honolulu Engineer District

1. Project Name: Manele SBH
2. Date of Inspection: April 6, 2007
3. Inspection Personnel:

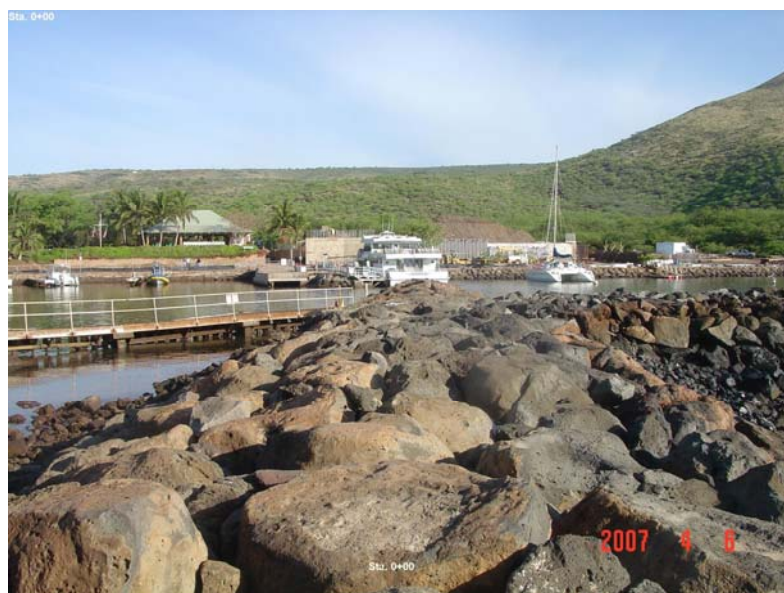
- a. Overview at start of the existing Stub Breakwater from trunk to root. Ocean side is to the right, and harbor side is to the left.

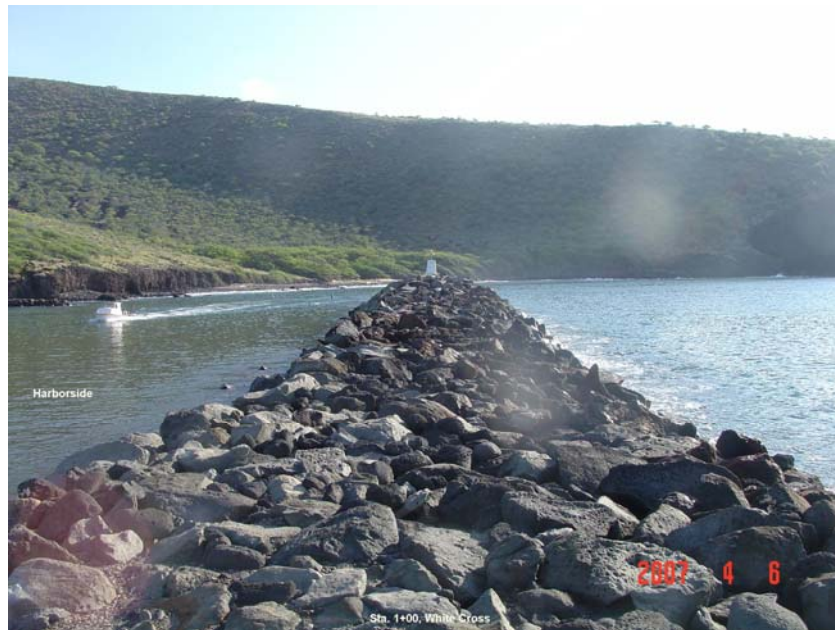
b. Overview at end of project from trunk to head. Ocean side is to the right, and harbor side is to the left.

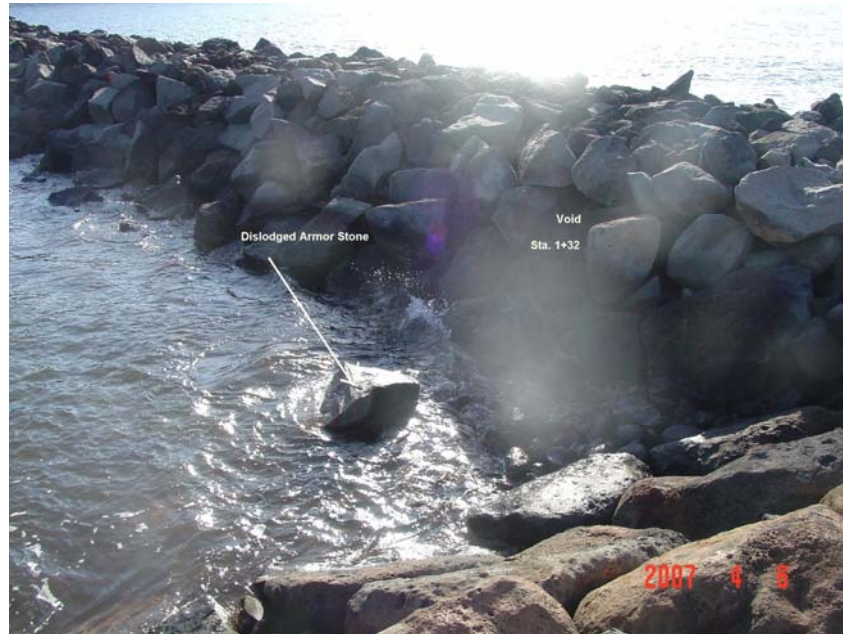
c. Sta. 1+32, HS, dislodged armor stone 3' from toe. Void is half way up side slope.

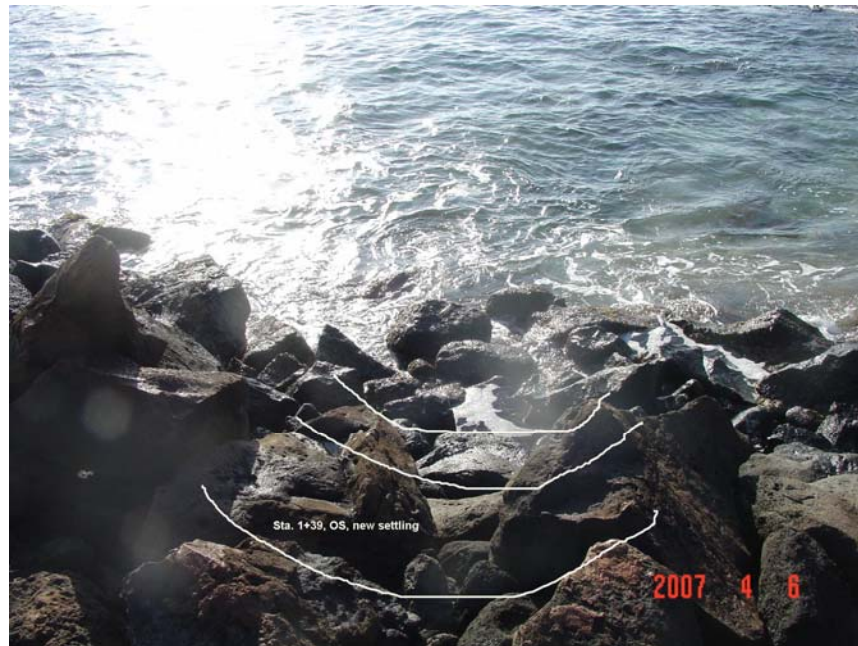
d. Sta. 1+39, OS, dislodged armor stone w/ voids, lower sideslope failure. Additional settling at sideslope this year.

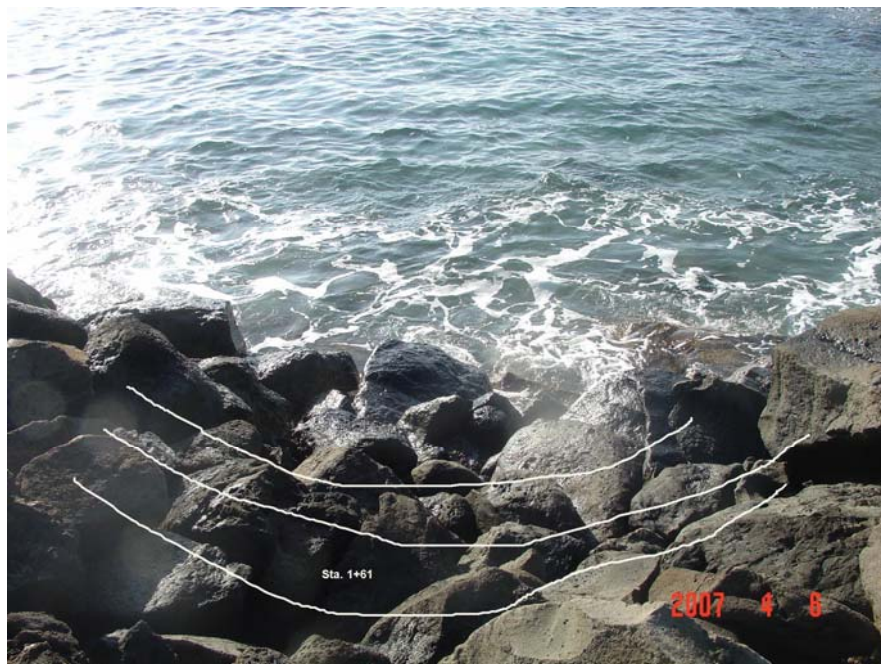
e. Sta. 1+61, OS, sideslope failure. 8 LF hinge to toe under layer exposed. Additional settling at sideslope this year.

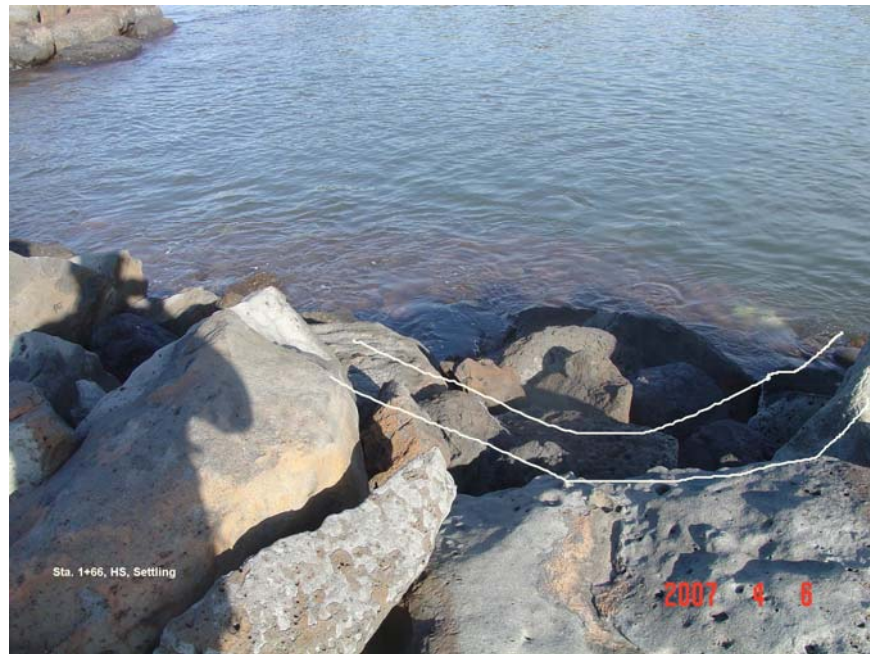
f. Sta. 1+66, HS, Sideslope settling, additional settling at sideslope this year.

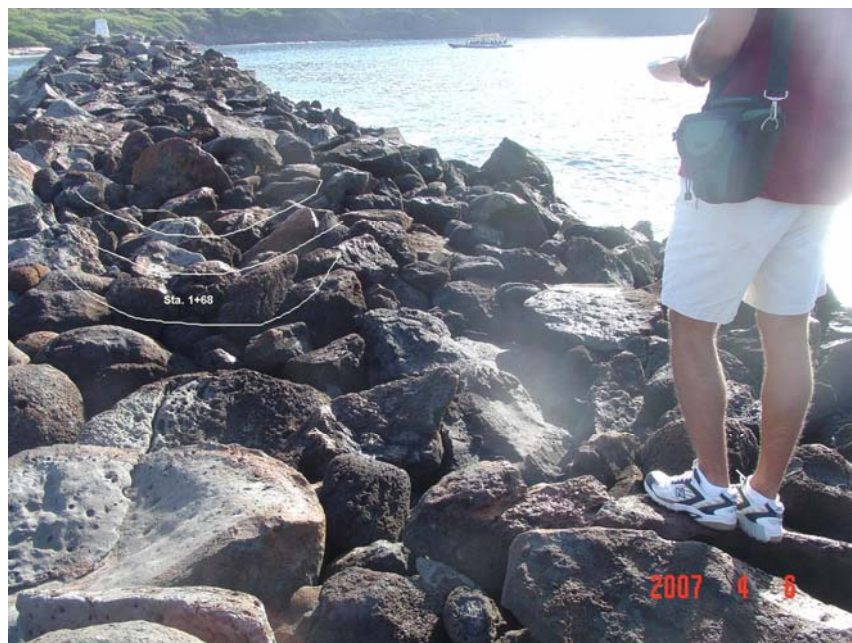
g. Sta. 1+68, Crest settling, new this year.

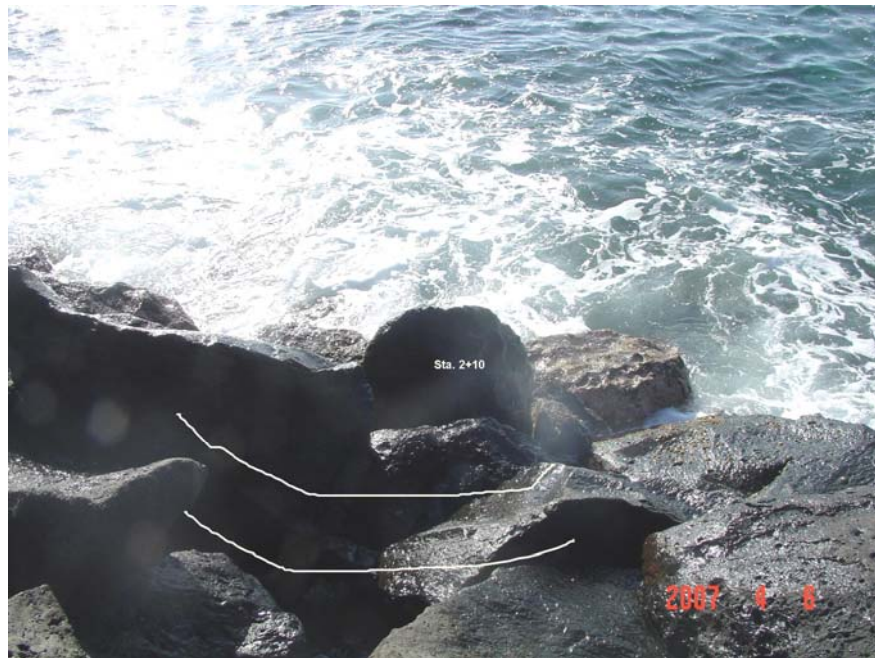
h. Sta. 2+10, Hinge movement, new this year. Additional settling at sideslope this year.

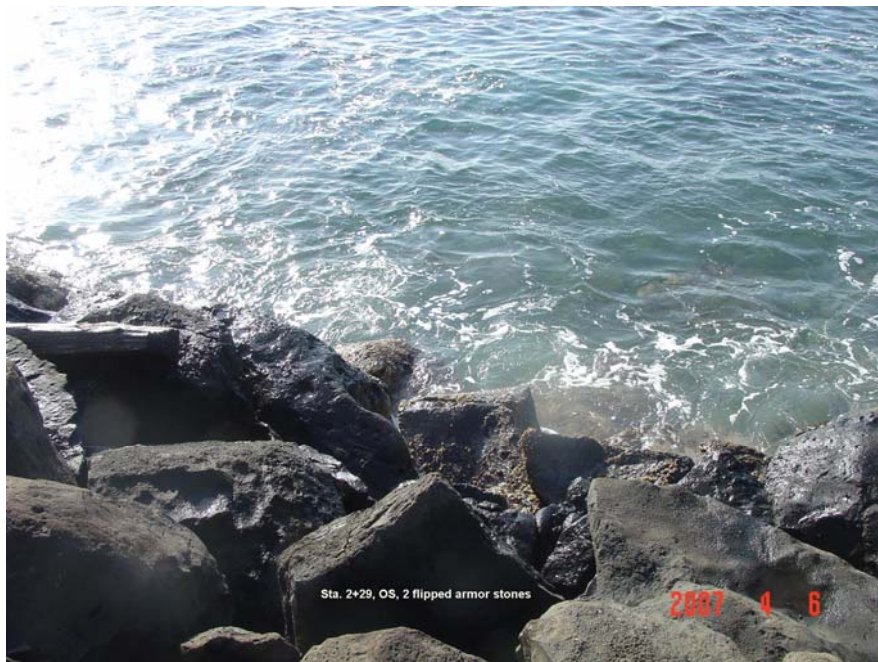
i. Sta. 2+29, OS, 2 flipped armor stones on side slope.

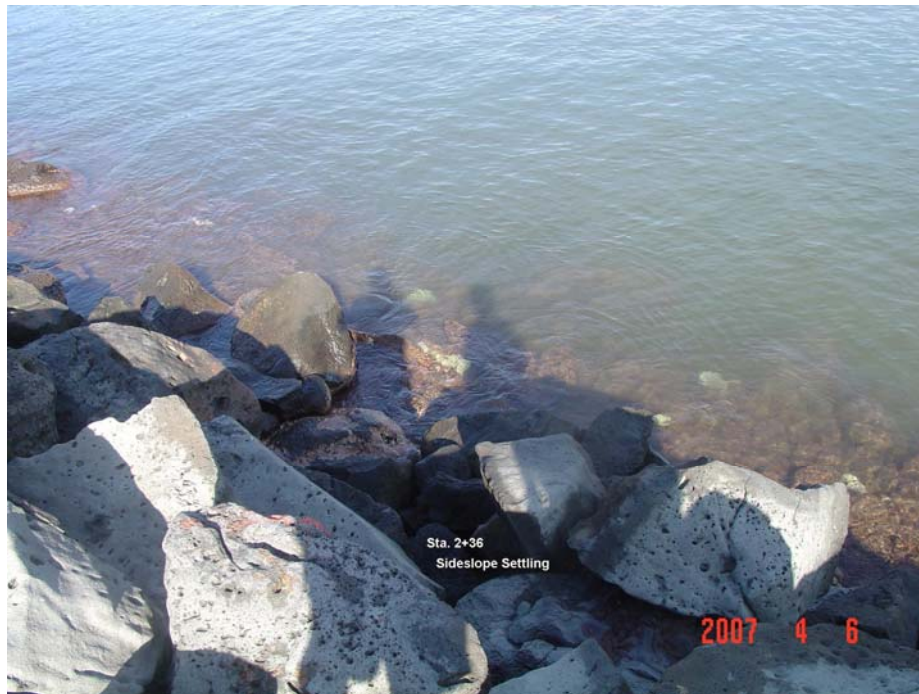
j. Sta. 2+36, Previous inspection was void at crest, new deficiencies is OS, sideslope failure.

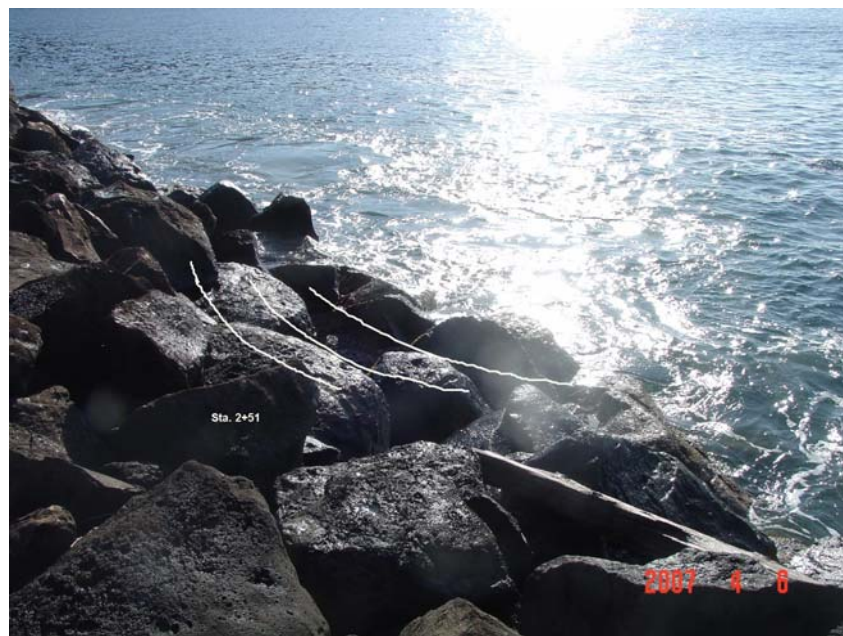
k. Sta. 2+51, OS, side slope steepening. Void under side slope. Under layer not exposed.

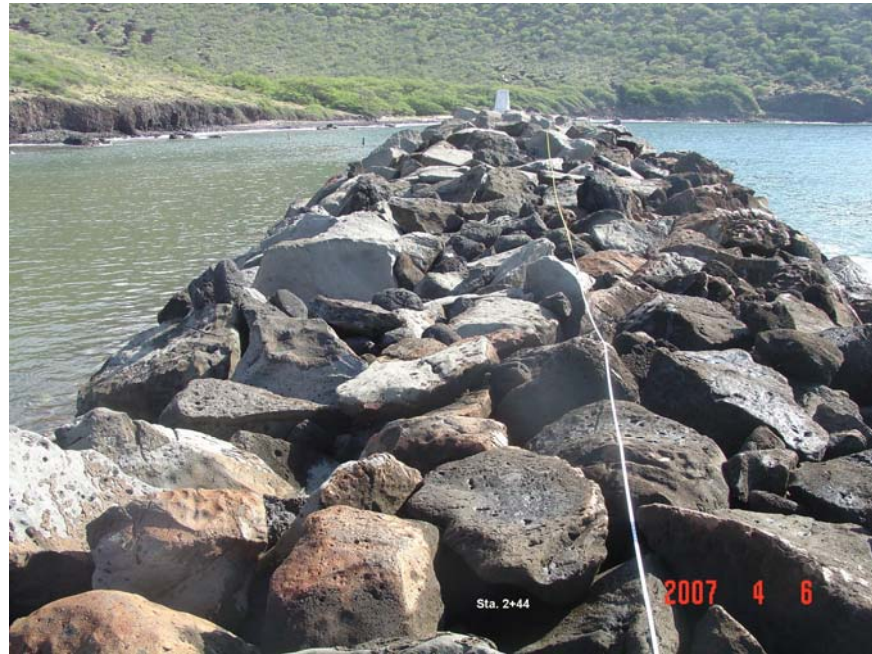
1. Sta. 2+44, Crest settling, new this year.

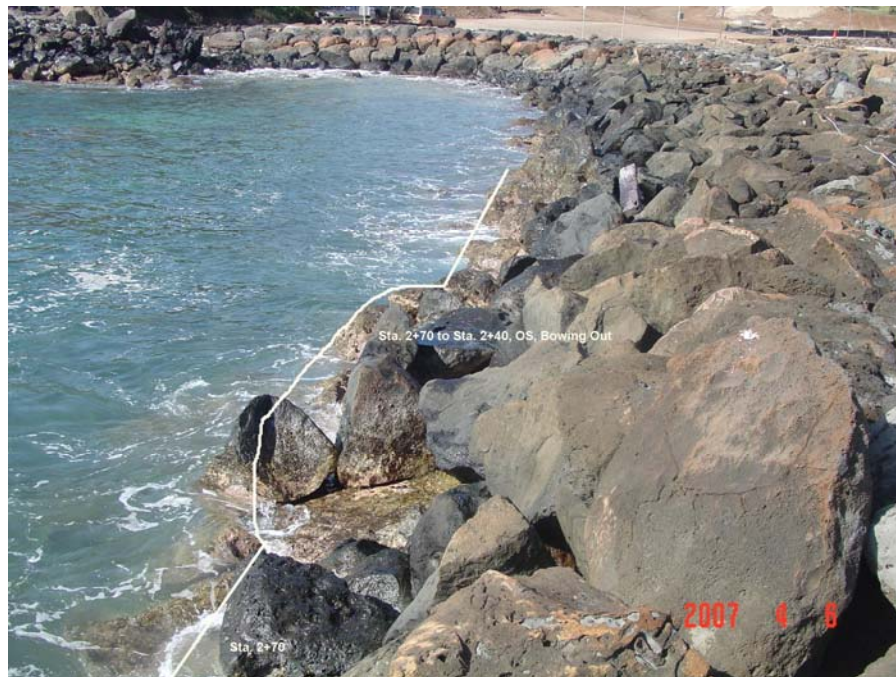
- m. Sta. 2+40 to Sta. 2+70, OS, toe creep & sideslope settling (Bulge).

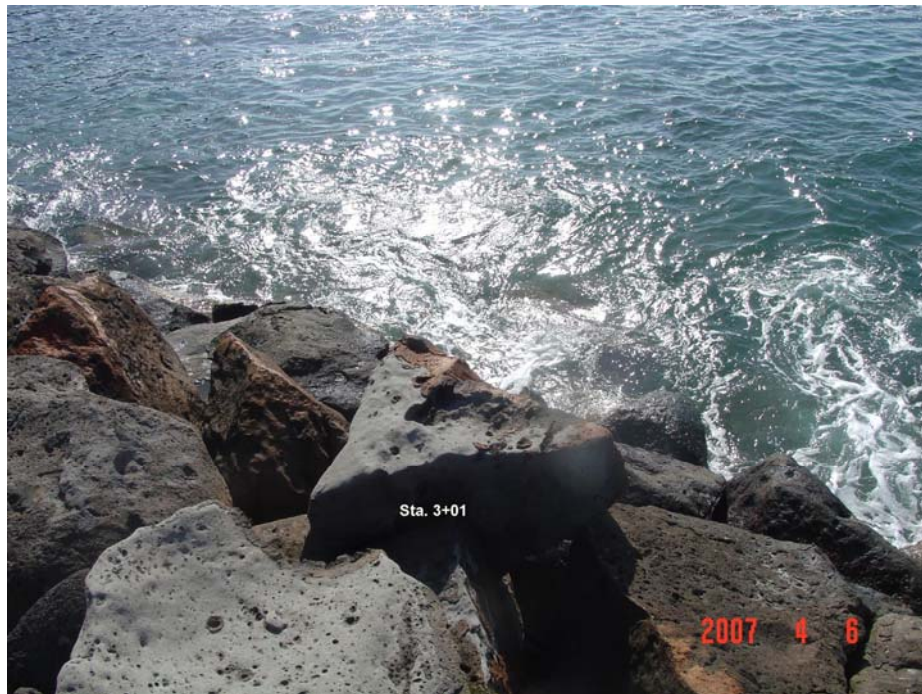
n. Sta. 3+01, OS, 1 armor stone resting at hinge, bridging.

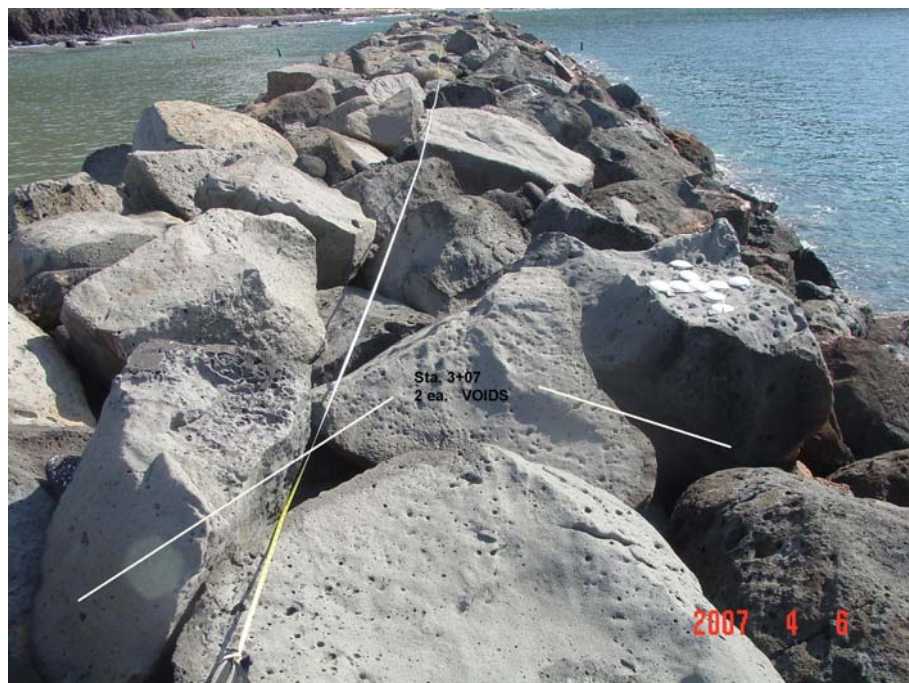
o. Sta. 3+07, Void centerline of crest, new this inspection, adjacent white cross.

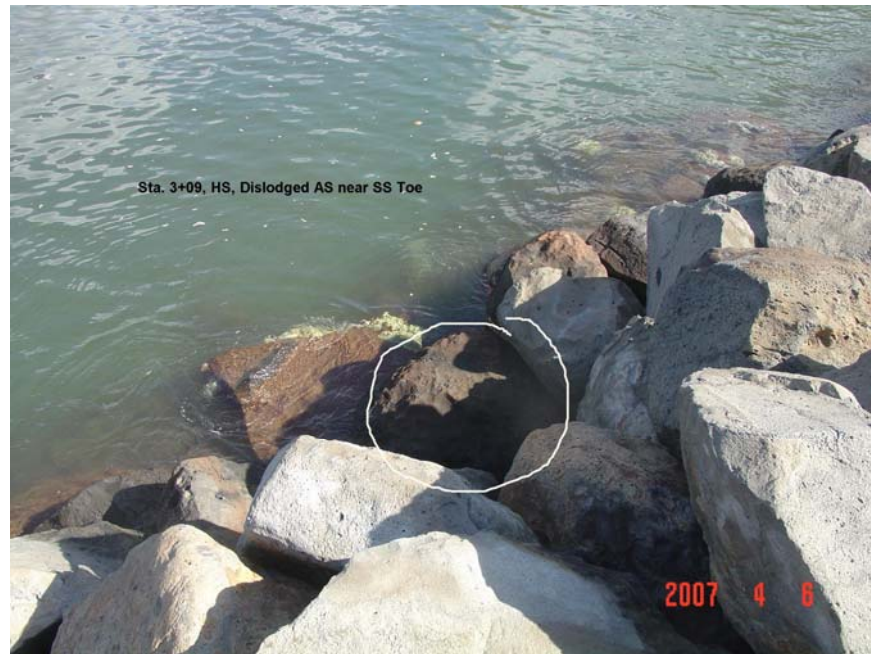
p. Sta. 3+09, HS, dislodged armor stone at the toe.

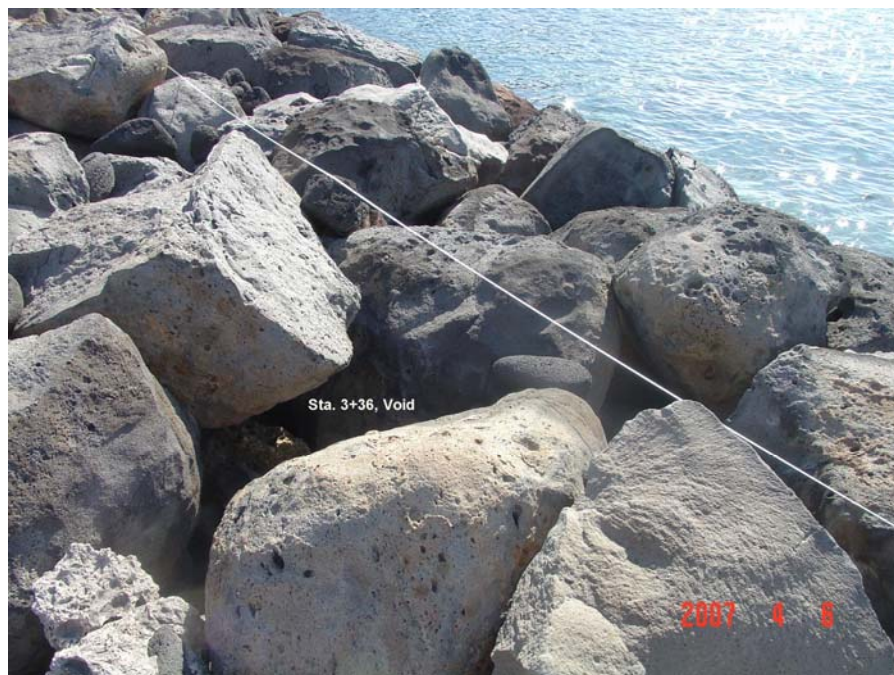
q. Sta. 3+40, 2 large voids at center line of crest. No Change.

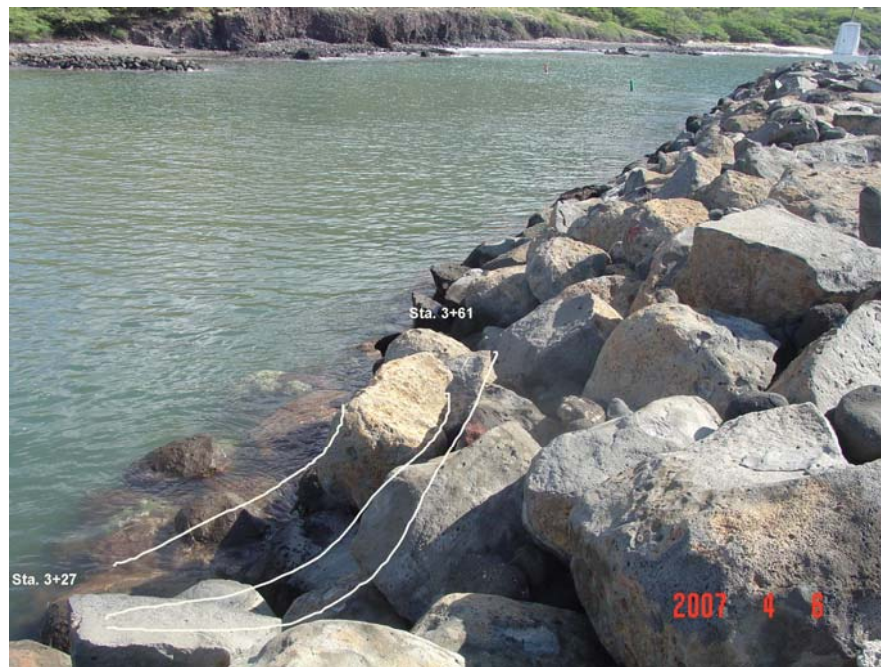
r. Sta. 3+27 to Sta. 3+61, HS, sideslope failure.

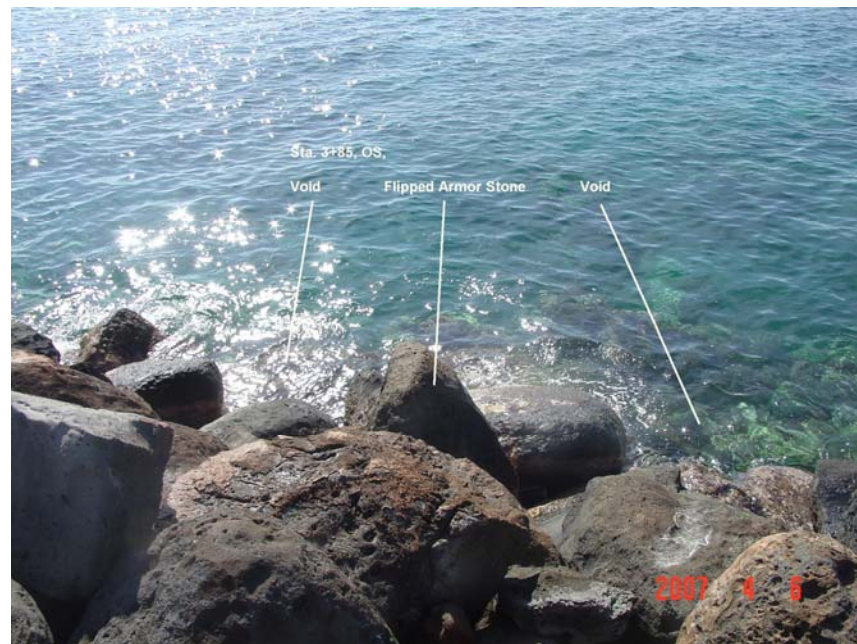
s. Sta. 3+85, OS, 2 voids, 1 flipped armor stone.

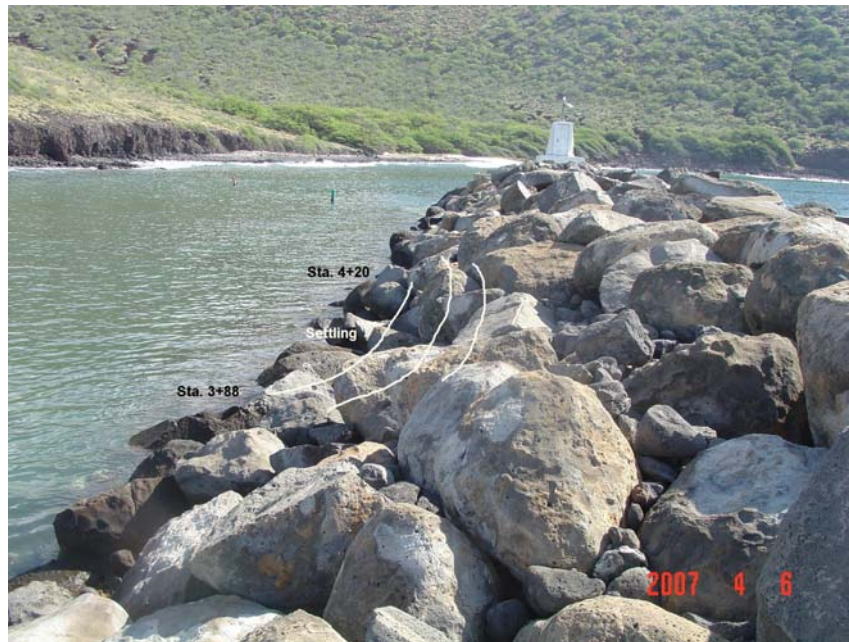
t. Sta. 3+88 to Sta. 4+20, HS, sideslope setting.

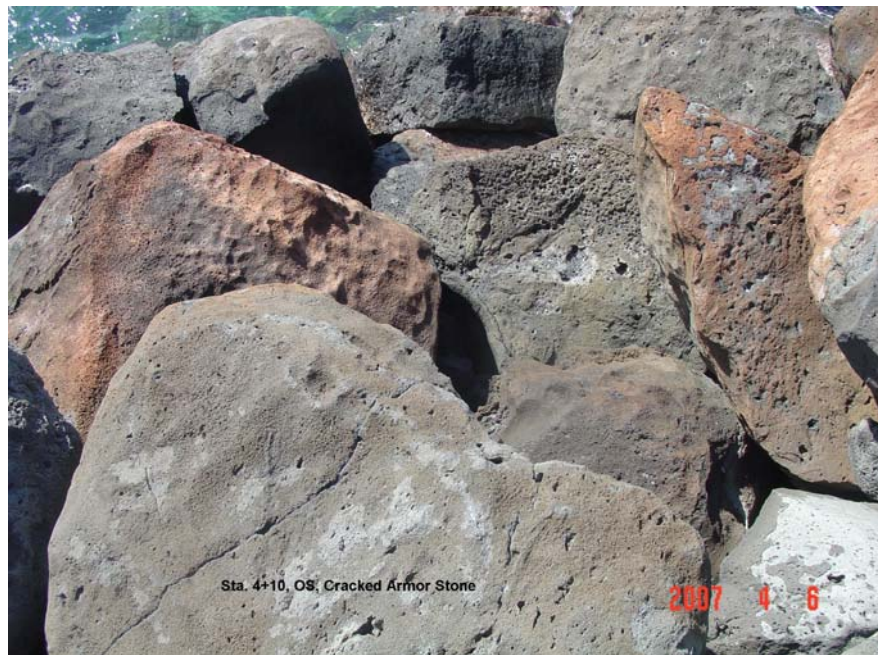
u. Sta. 4+10, OS, 1 crack armor stone at hinge with void.

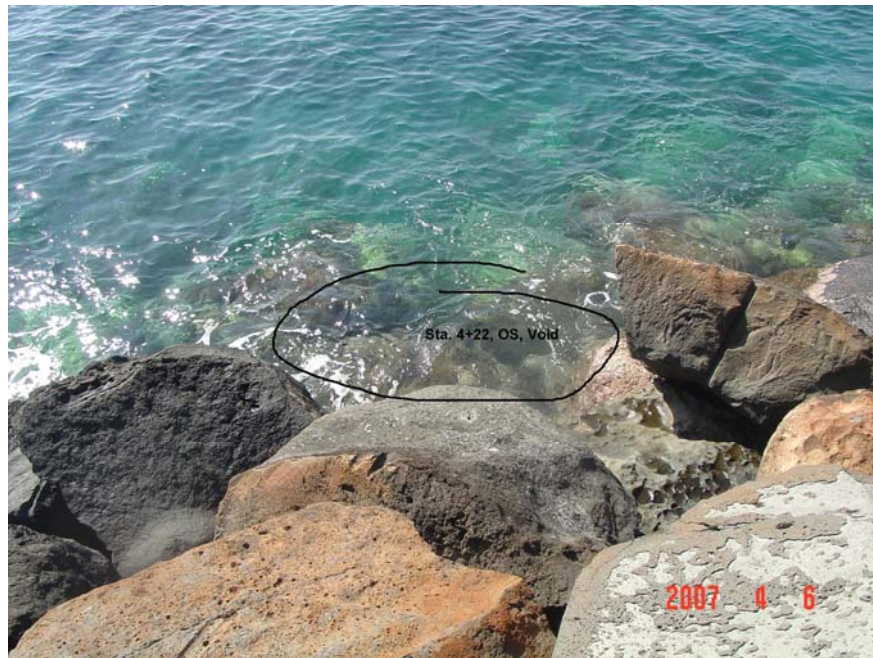
v. Sta. 4+22, OS, 1 armor stone dislodged resting on side slope, 1 fractured armor stone, void at waterline.

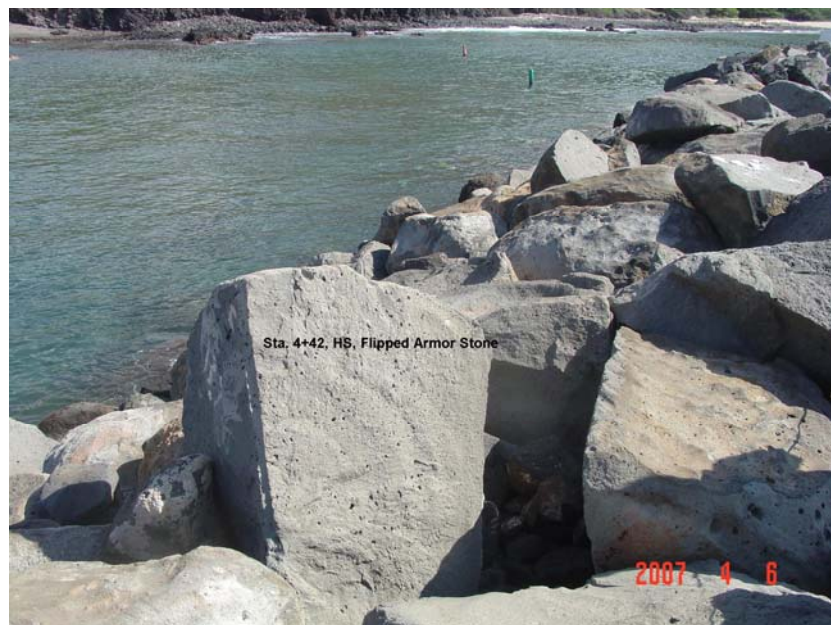
w. Sta. 4+42, HS, flipped armor stone.

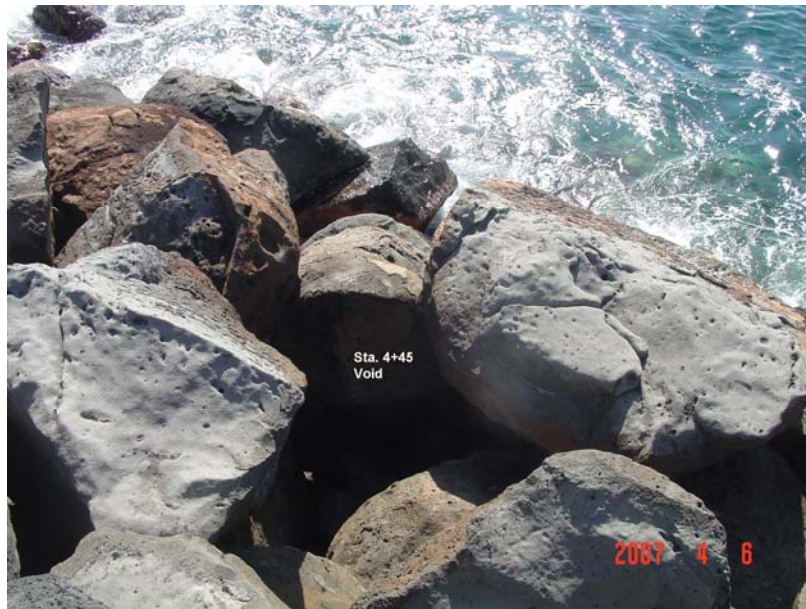
x. Sta. 4+45, OS, hinge, void.

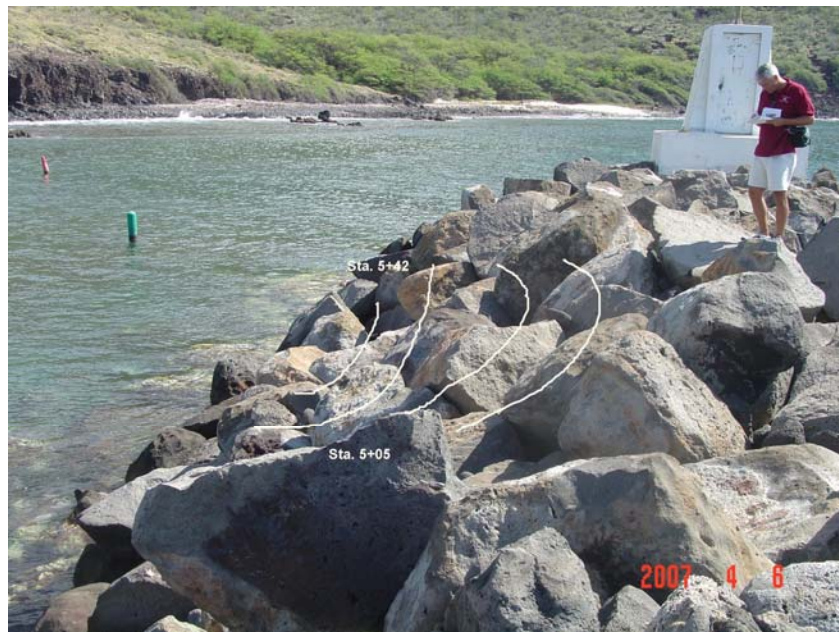
y. Sta. 5+05 to Sta. 5+75, HS, sideslope settling at hinge to waterline.

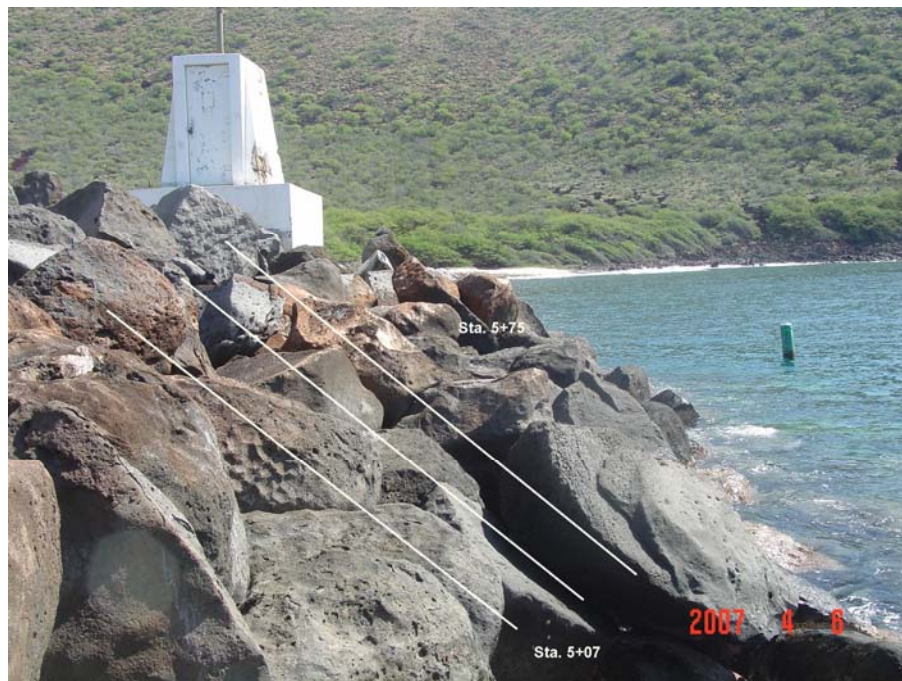
New deficiencies were noted on this inspection and are indicated. The Oceanside (OS) of the structure at Sta. 4+95 thru Sta. 5+70 has dramatic changes this inspection and has deteriorated drastically.

z. Sta. 5+07 to Sta. 5+75, OS, sideslope steepening and settling at hinge to waterline.

After review of the past O&M inspections it appears the project was constructed with "extreme" randomness with respect to the armor stone placement and the noted items, while not the result of wave energy, are being exacerbated by wave action. The armor stones are not keyed and fitted resulting in loose and undersized which cause rocking. The lack of interlocking stones has created large voids, bridging, perched rocks, and exposed under layers and cores to direct wave action. The past photos reveal a steady decline in the contact of the armor stones. There has been a significant change in Sta. 4+95 to Sta. 5+70, OS, this year.

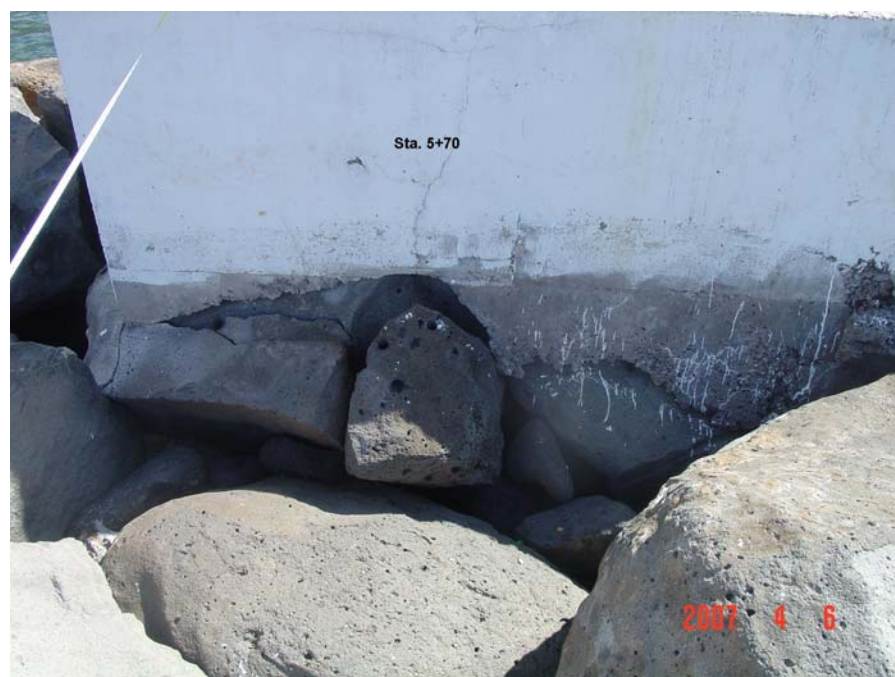
aa. Sta 5+70, crest settling under NavAid foundation.

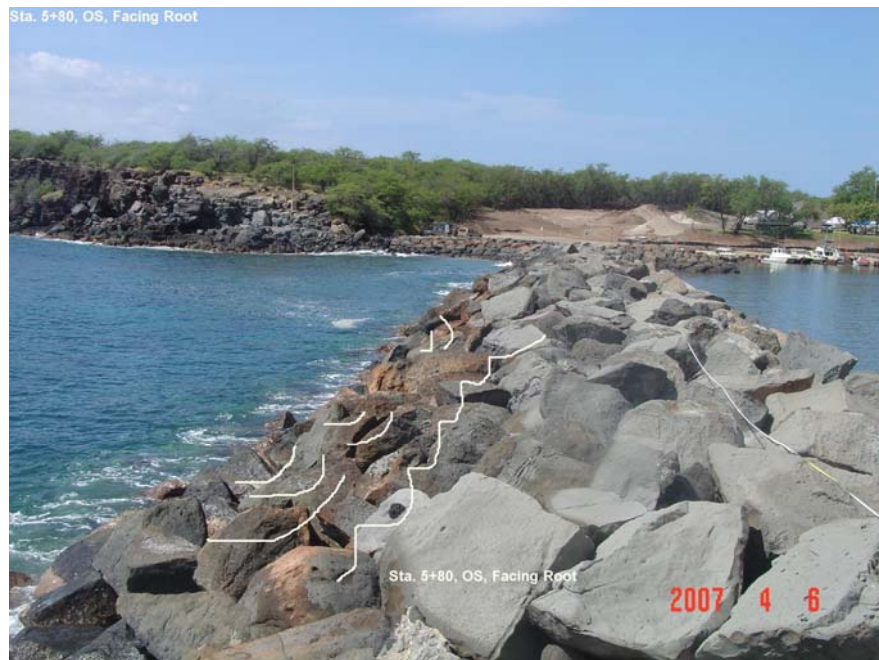
bb. Reference Photo, Head to Root OS.

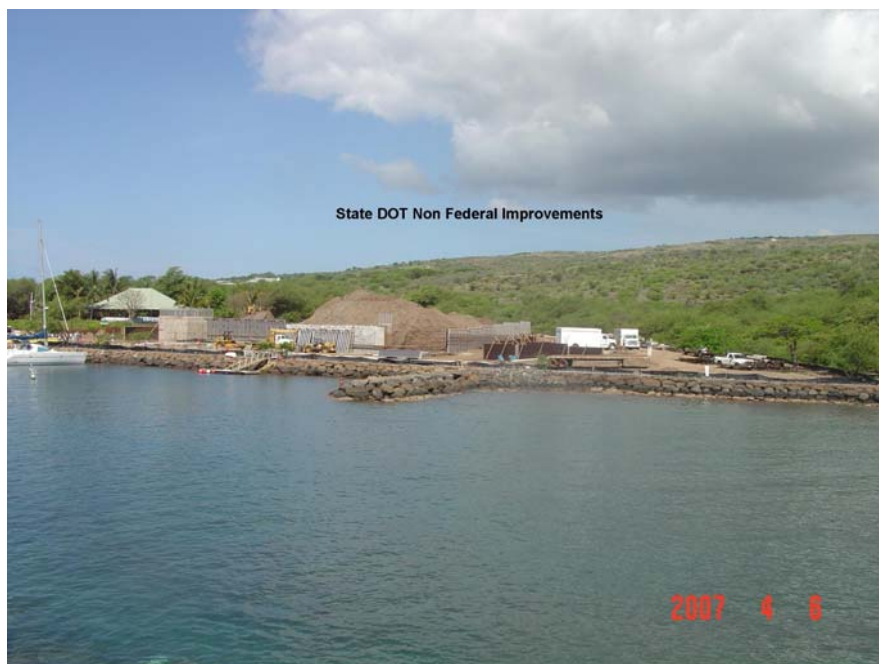
cc. Non-Federal Parking Lot improvements at harbor.
